Multi-Media Compliance Evaluation Inspection
USEPA Region III
Office of Enforcement, Compliance, and Environmental Justice

Pentagon Reservation
United States Department of Defense
425 Old Jefferson Davis Highway
Arlington, Virginia 22202

Inspection Dates: May 10, 2010 to May 12, 2010

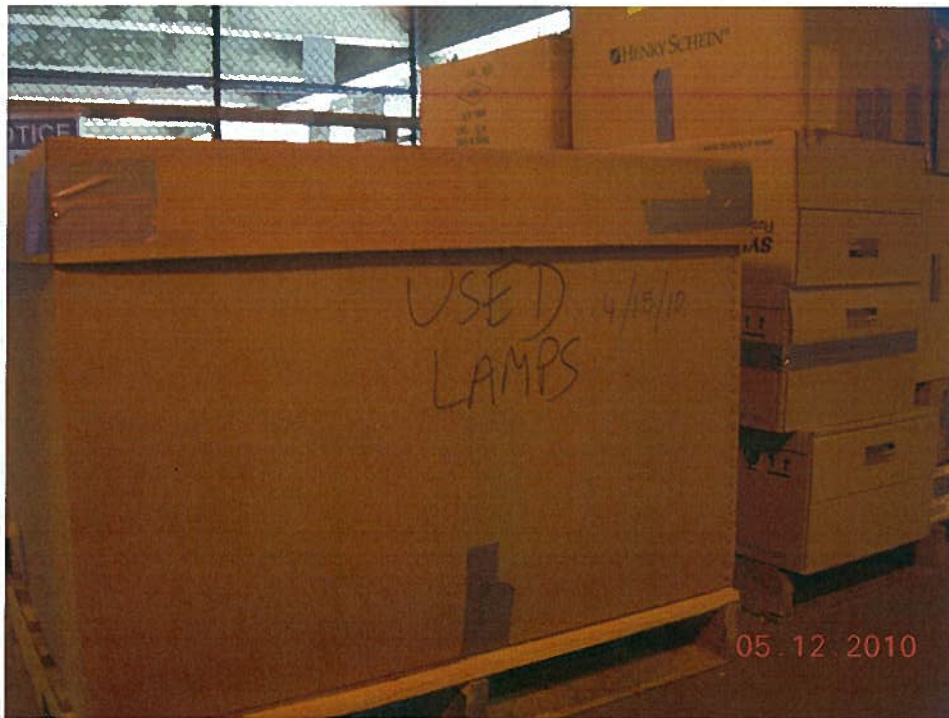
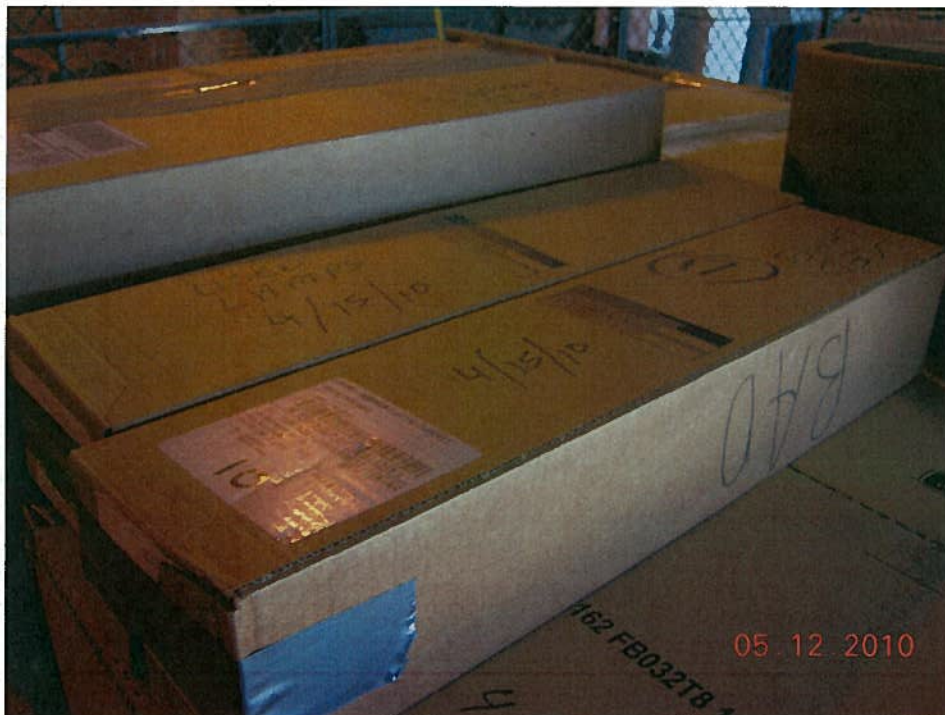
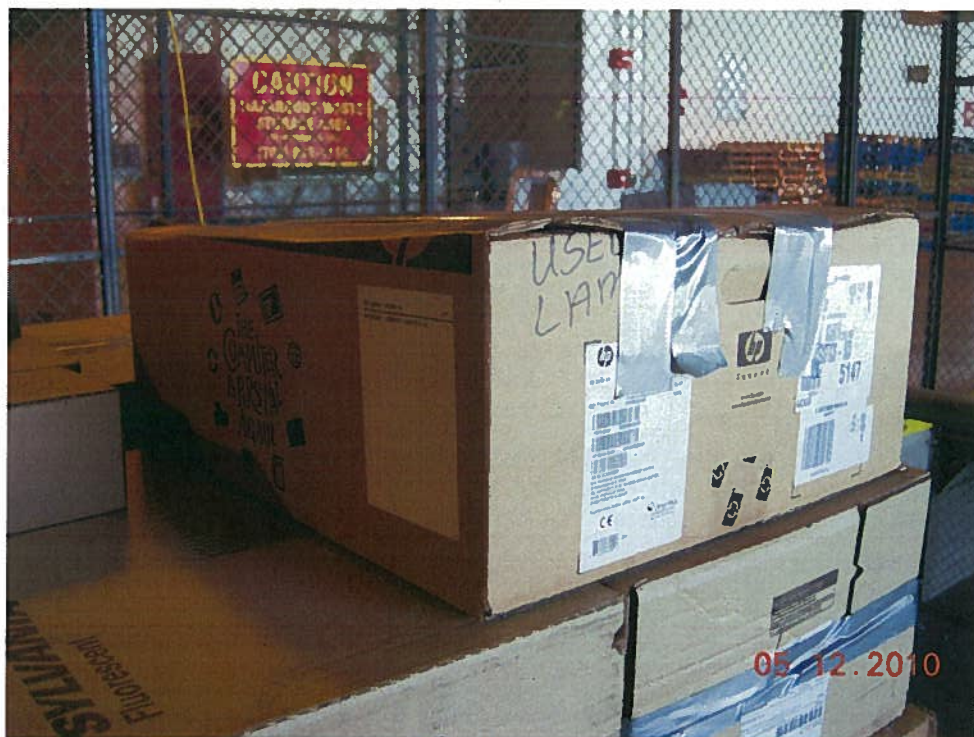
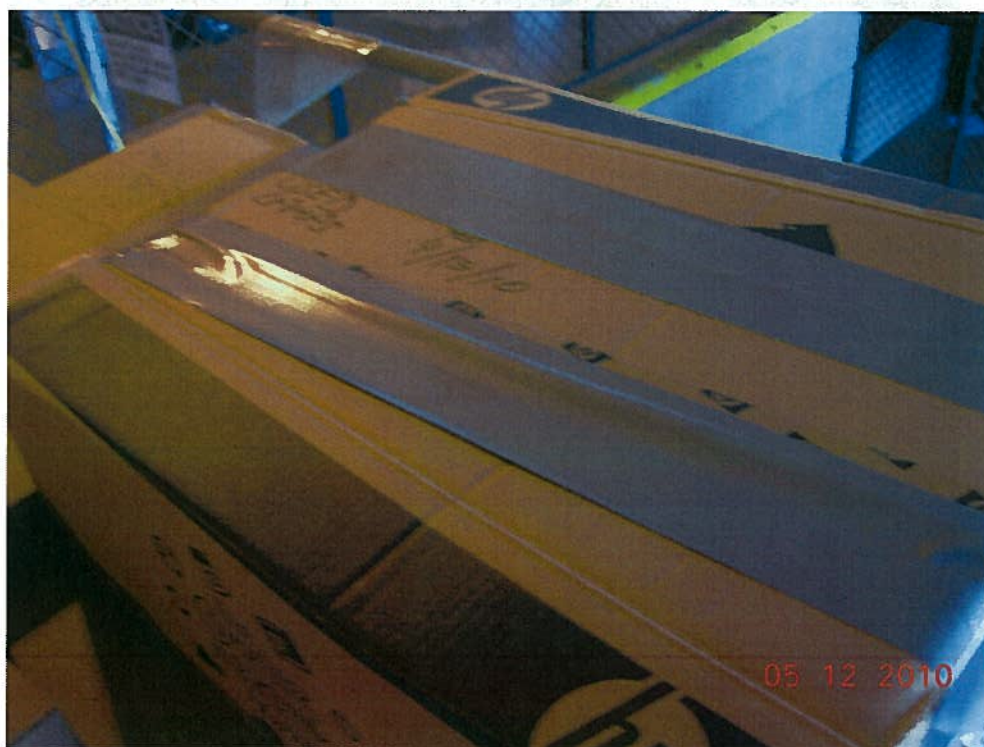
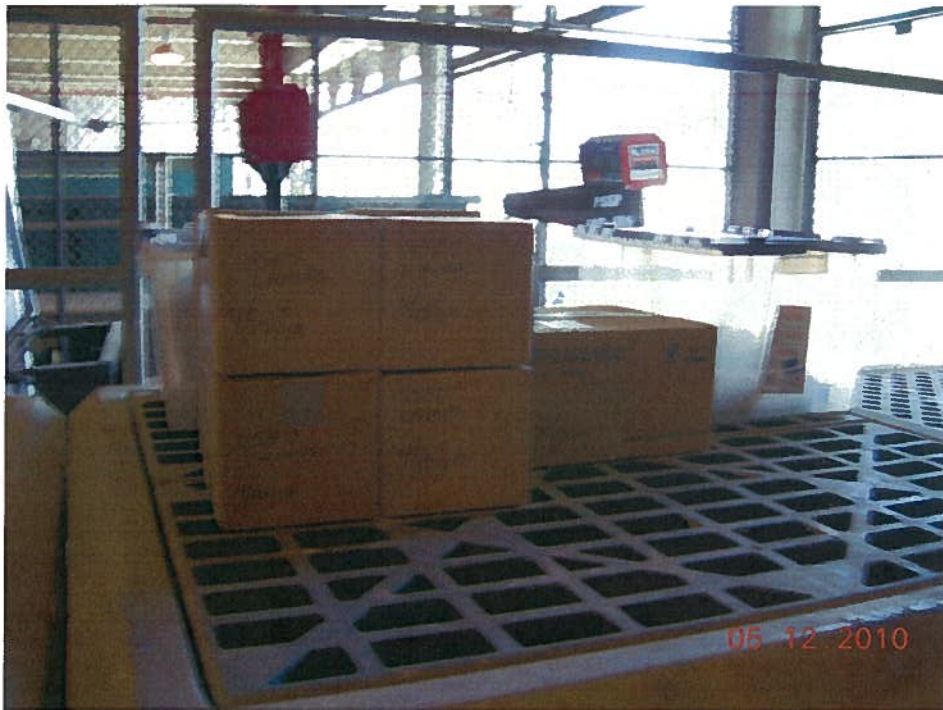
The storage area consisted of two main bays (Bay 5 and 6). On May 10, 2010, Mr. Young visited the less than 90-day hazardous waste storage area with Bob Klugiewicz, an Environmental Protection Specialist representing the Facility. During the initial visit to the less than 90-day hazardous waste and universal waste storage areas, Mr. Klugiewicz stated he did not have the key to access the area. The inspector was able to view through the cages and see that the Facility was storing universal waste lamps and batteries. Mr. Young was unable to access the inside of the cage; however he was able to observe the boxes from where he stood. Based on the shape of the boxes and information provided by the Facility, he estimated that there were approximately 23 boxes of used lamps which were being stored, none of which had an accumulation start date on the box. There was a large cardboard box collecting universal waste lamps that did not have a closed lid. There were no lamps being added to this box at the time of this observation.

Mr. Young revisited the less than 90-day hazardous waste and universal waste storage areas again on May 11, 2010, because the field contractor for Bishop Inc., Mr. Mundt was available. Upon meeting Mr. Mundt, he stated the gates to the main storage area were never locked. Mr. Mundt stated the basic process of collecting waste is a combination of Bishop Inc. going out and collecting waste from the Facility along with Facility personnel, and other contractors bringing in waste for disposal. With this system in place, sometimes waste is brought in after hours and just left at the storage area. This type of collection process is why the Facility had a large cardboard box with an open top of universal waste.

RCRA-C 1: Universal waste lamps in MAA (Main Storage Area)

RCRA-C 2: Universal waste lamps in MAA (Main Storage Area)

RCRA-C 3: Universal waste lamps in MAA (Main Storage Area)

RCRA-C 4: Universal waste lamps in MAA (Main Storage Area)

RCRA-C 5: Universal waste lamps in MAA (Main Storage Area)

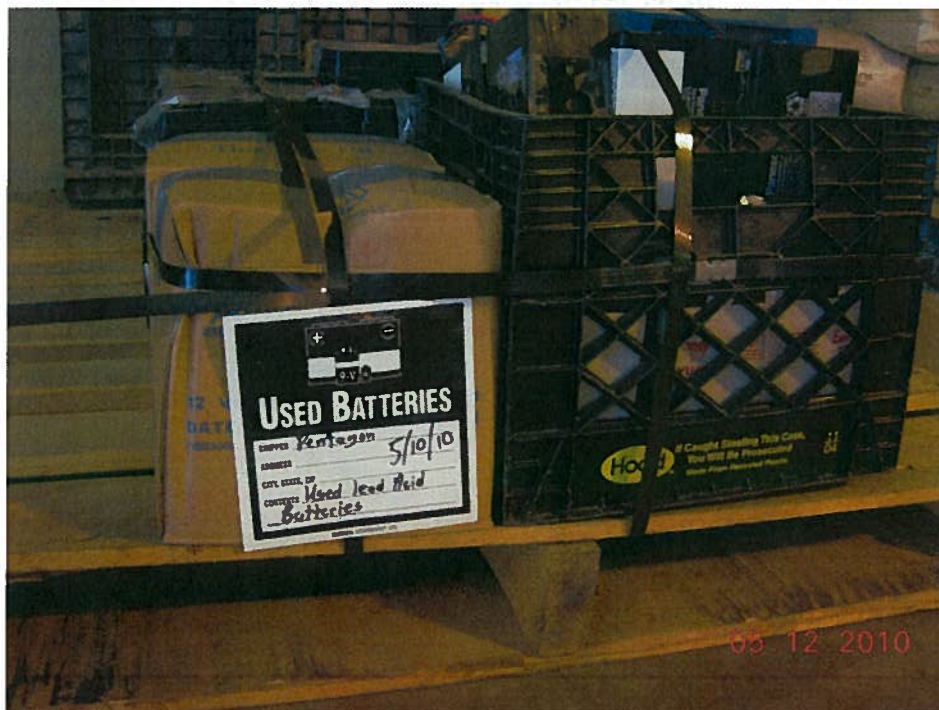
RCRA-C 6: Universal waste batteries in MAA (Main Storage Area)

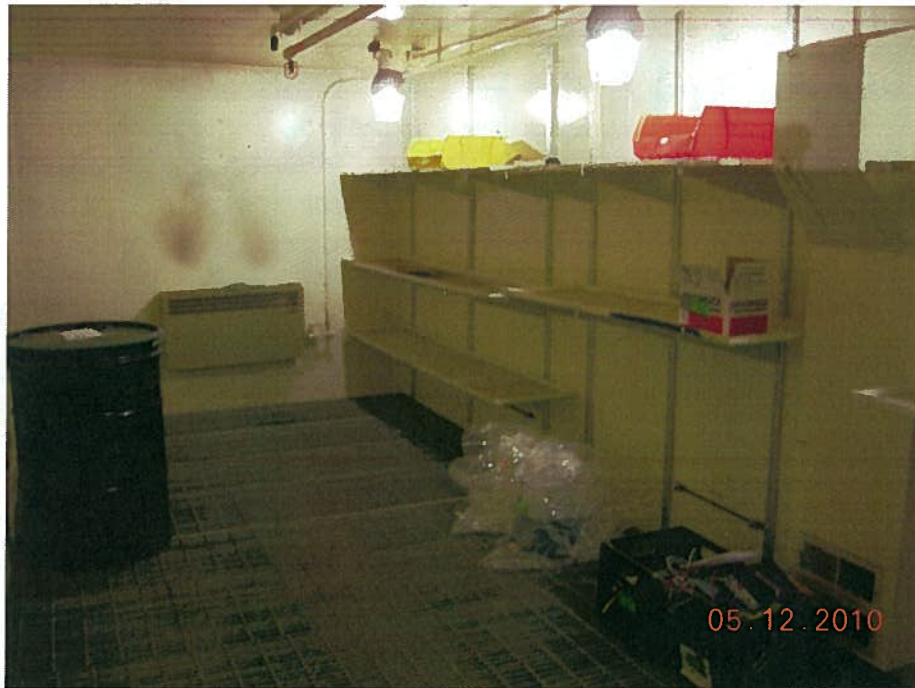
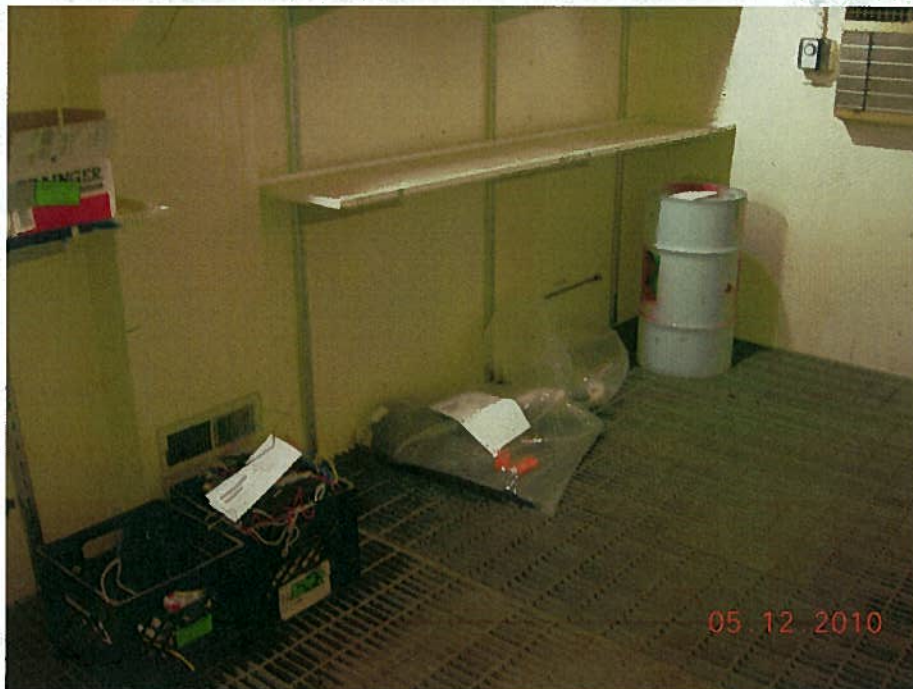
- Bay #1 – There was a 20-gallon container with a hazardous waste sticker labeled used weapons cleaning solution, which was dated 5/5/2010. There were also two clear plastic bags of hazardous waste weapons cleaning debris and lead aprons. Both bags were affixed with hazardous waste labels and a start accumulation date of 5/6/2010 and 5/7/2010 respectively. The container and plastic bags were closed. (See RCRA-C photo #7, #8)

RCRA-C 7: Hazardous waste storage Bay#1

RCRA-C 8: Hazardous waste storage Bay#1

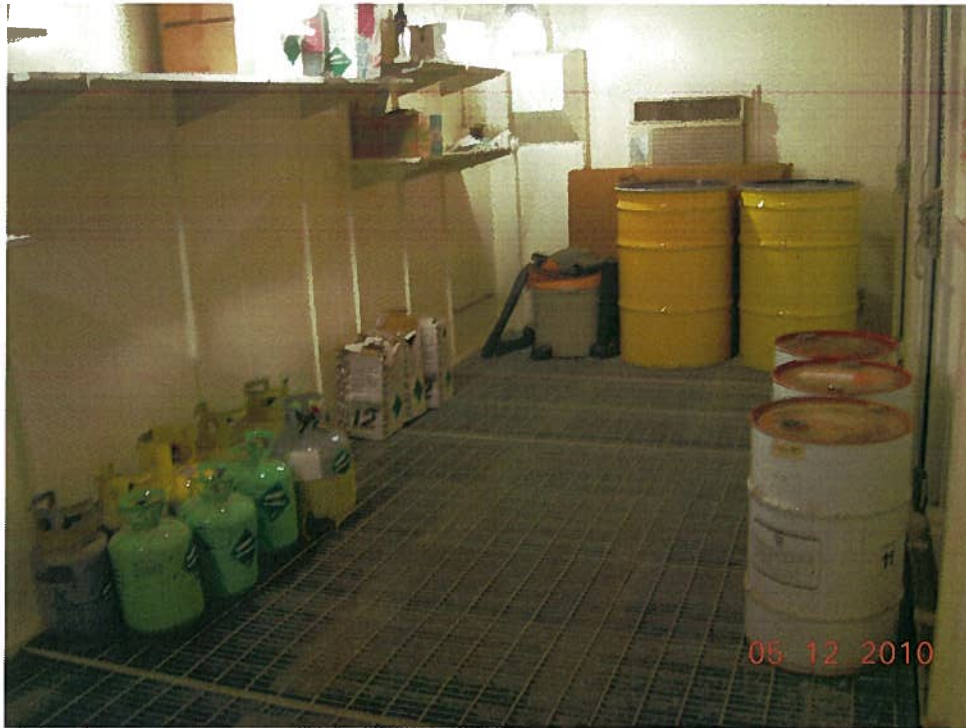
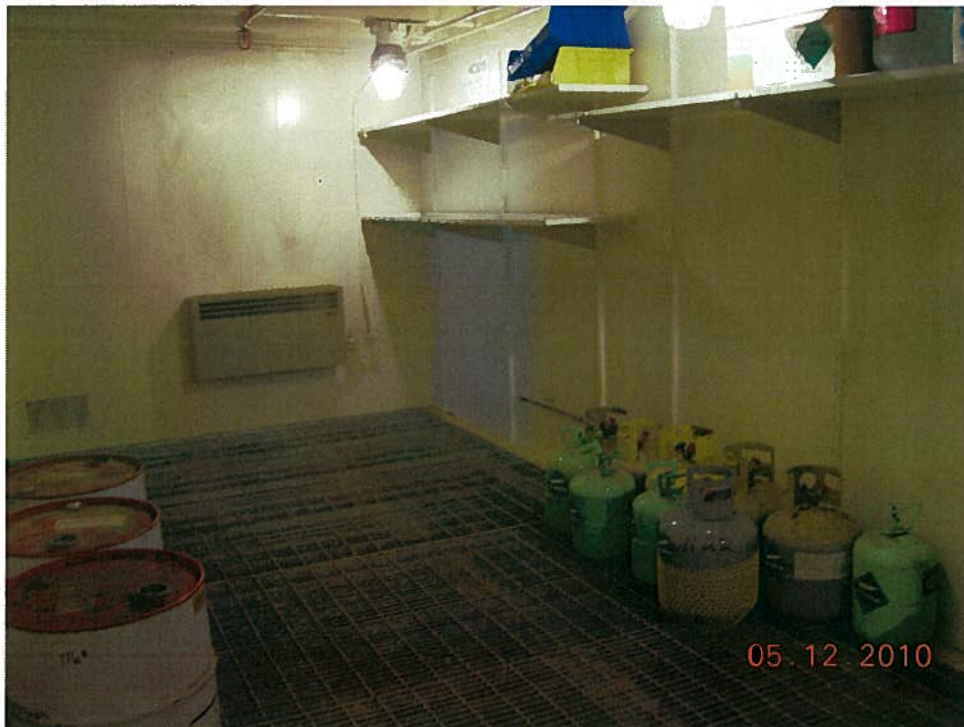
- Bay #2 – There was an epoxy waste with a hazardous waste sticker labeled adhesive basic and with a start accumulation date of 4/15/2010. There was a cardboard box of lithium batteries with a universal waste sticker, but it did not have a start accumulation date on the container. There was a tracking and shipping document that showed the container came in on 4/14/2010. A bag of alkaline batteries had a universal waste label and start date of 4/14/2010. Freon was also located in this bay. There was a cylinder of R-134a with a date of 5/4/2010, along with a cylinder of R414B with a date of 4/30/2010. There were also two boxes of CFC-113 that had a hazardous materials label with a date of 4/27/2010, (See RCRA-C photos #9, #10).

RCRA-C 9: Hazardous waste storage Bay#2

RCRA-C 10: Hazardous waste storage Bay#2

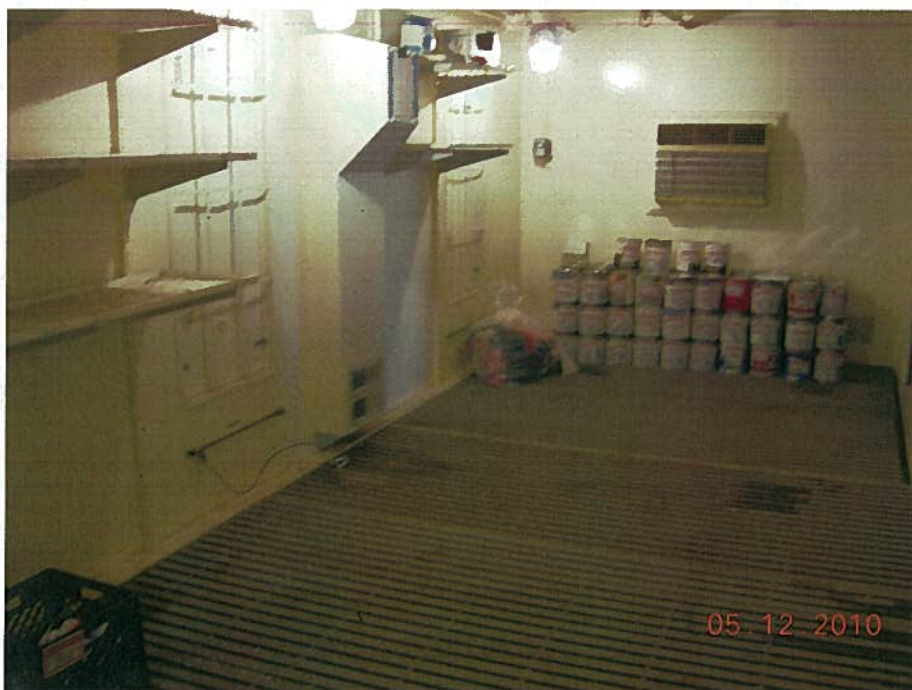
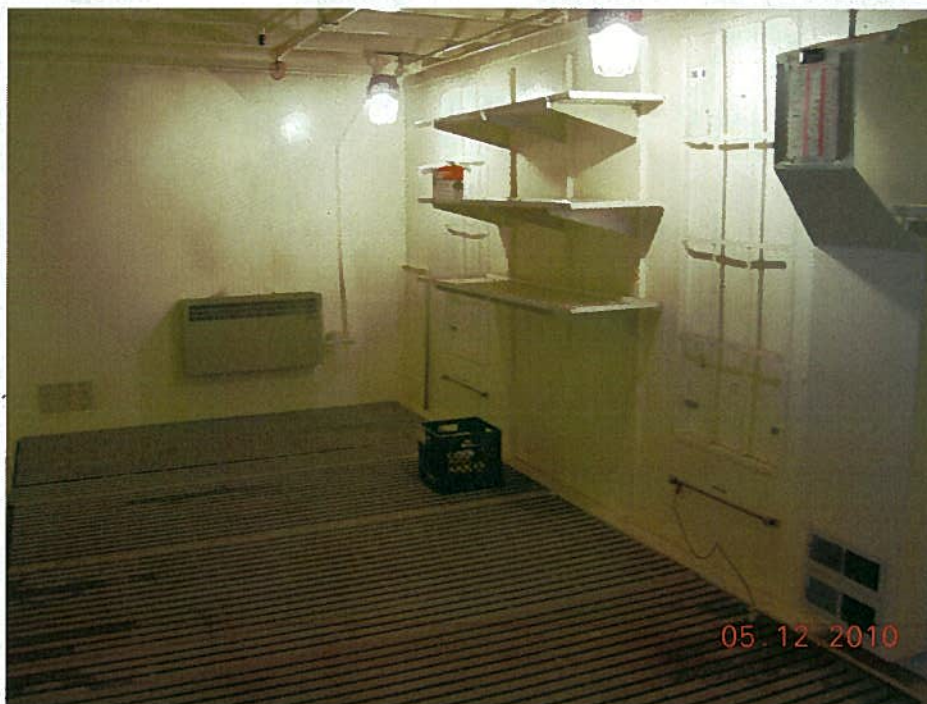
- Bay#3 – There was a large clear plastic bag with a hazardous waste sticker with a start accumulation date of 5/7/2010, which held rags contaminated with paint thinner. The plastic bag was closed by means of wrapping duck tape around the opening of the plastic bag. Mr. Young was unable to confirm the VOC concentration of the rags. Along with the plastic bag, there was a can of flammable adhesive with a hazardous waste sticker and start accumulation date of 4/27/2010. There was also a milk carton with multiple aerosol cans. The milk carton itself had a hazardous waste label with a start accumulation date of 4/20/2010, but each aerosol container was not individually labeled.

On May 12, 2010, Mr. Young went back to less than 90-day hazardous waste and universal waste storage areas to take photographs. The large cardboard box which had an open top and no start accumulation date was now closed with a start accumulation date of 4/15/2010, (See RCRA-C photo #1). Along with this large cardboard box, the Facility now labeled and closed all of the remaining cardboard boxes. A date of 4/15/2010, was put on each cardboard box (See RCRA-C photos #2, #3, #4, #5). The Facility also wrote a start accumulation date of 5/10/2010, for the bundle of batteries (See RCRA-C photo #6). Also, Mr. Young went back and took photos of the bay. At that time, the Facility added containers of paint. Each container had a hazardous waste sticker, (See RCRA-C photos #11, #12).

RCRA-C 11: Hazardous waste storage Bay#3

RCRA-C 12: Hazardous waste storage Bay#3

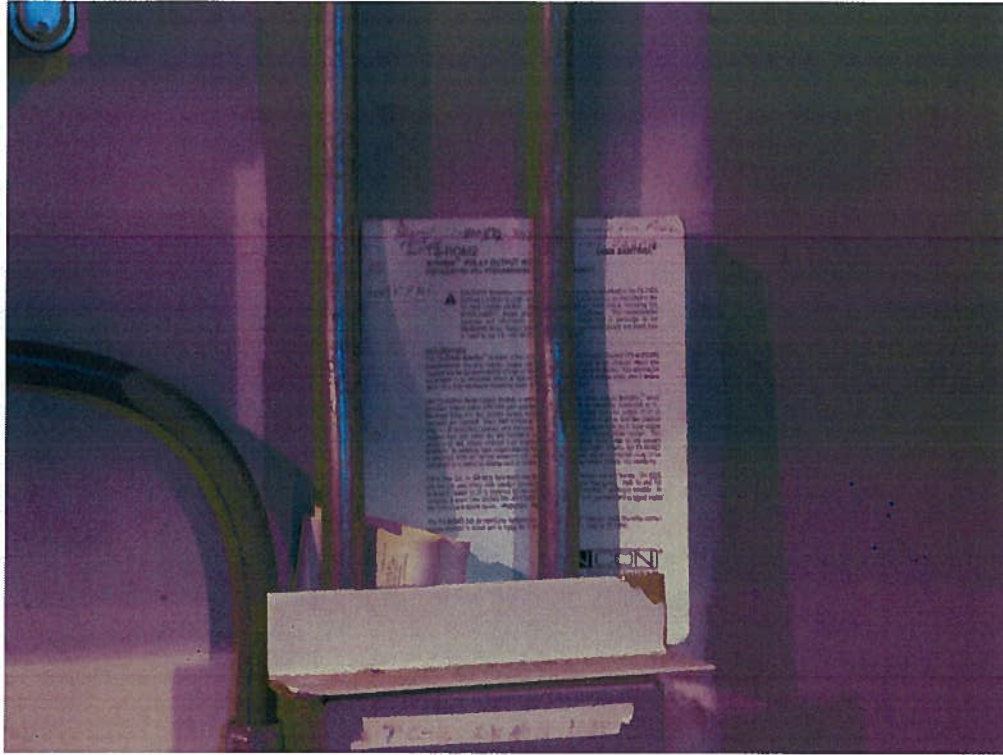
These USTs store No. 2 fuel oil solely for use in emergency power generators and tank release detection requirements do not apply to these UST systems. Nevertheless, both USTs are monitored with an INCON Tank Sentinel TS-1001 ATG monitoring system (see Photograph UST-18). The ATG monitoring system is set up to measure the tanks' fuel level and to monitor the tanks' interstitial space, among other things (see Attachment UST-3). Although capable of performing leak detection tests on the tanks, the ATG has not been set up to do so. During the inspection, the ATG displayed the messages "system okay," "tank okay," and "sensor okay," indicating that the fuel level probes and interstitial sensors for the USTs were operational (see Photograph UST-18). The Pentagon, however, did not keep any ATG reports to document the monthly monitoring of the tanks' interstitial space. Attachment UST-4 provides an ATG monitoring system report printed by the EPA inspector that documents that the interstitial sensor for the USTs were operational at the time of the inspection. The ATG probe connections for PU-2 and PU-3 are shown in Photographs UST-13 and UST-14. The INCON Tank Sentinel TS-1001 operating manual was present at the Facility at the time of the inspection (see Photograph UST-19).

Photograph UST-19 - ATG System Operating Manual

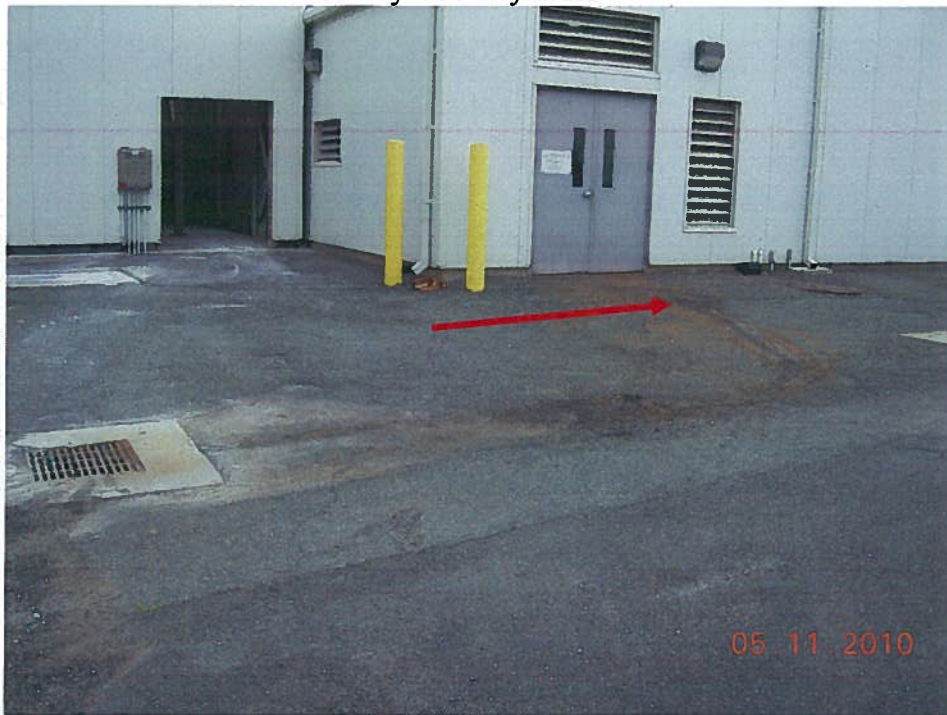
CWA 1: This photograph depicts the rear of the Incineration Plant. An unknown pipe drain was observed discharging, outside the compressor room, toward the storm drain. Incinerator ash was also observed near the storm drain.

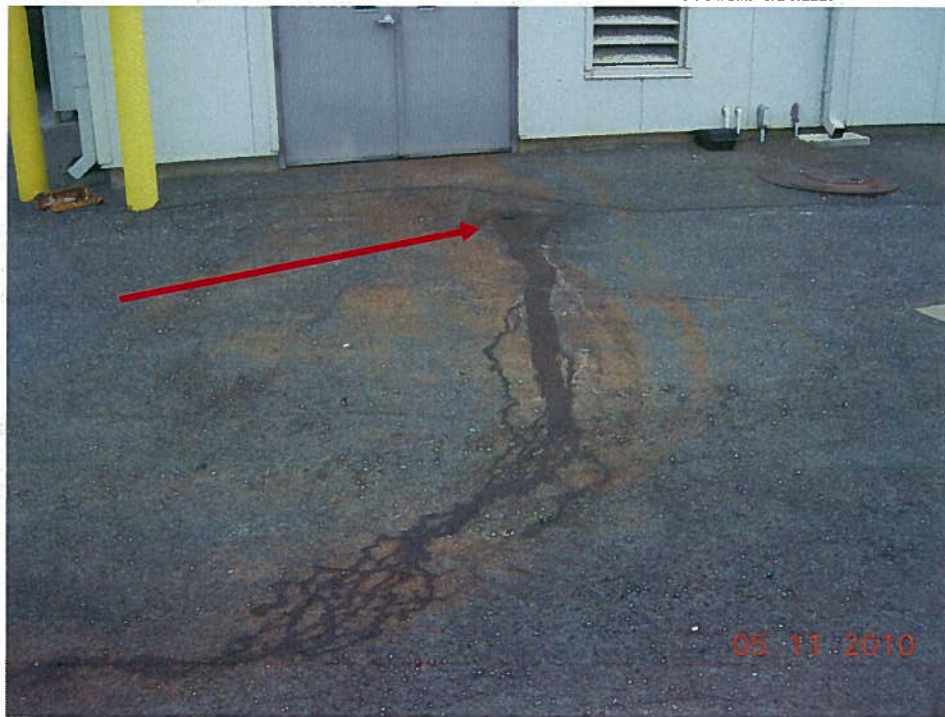
CWA 2: The unknown pipe was discharging liquid toward the storm drain.

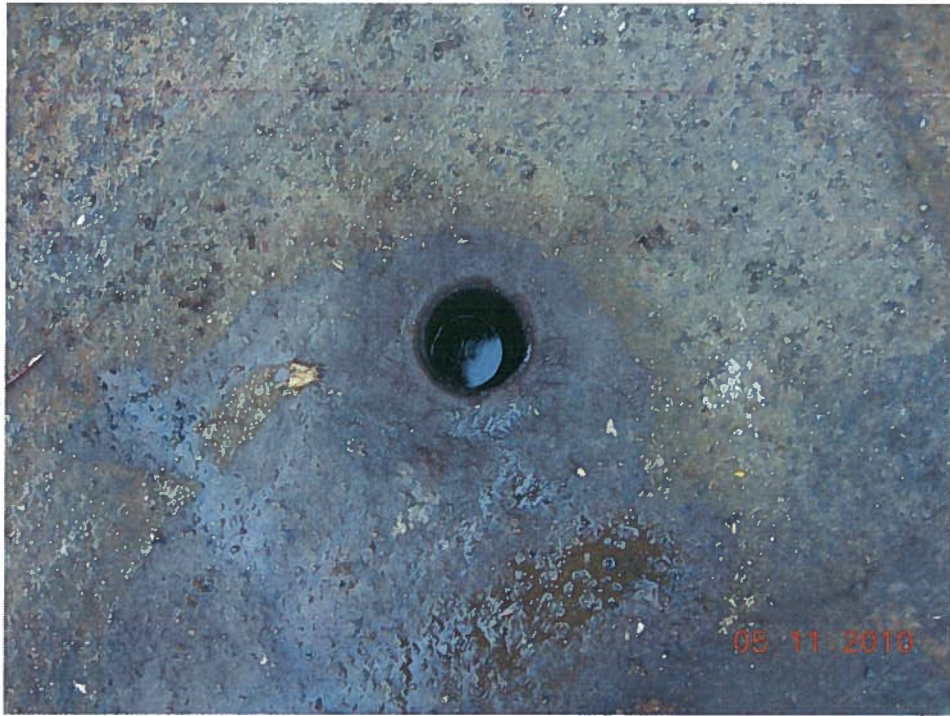
CWA 3: This photograph depicts a close-up of the unknown pipe.

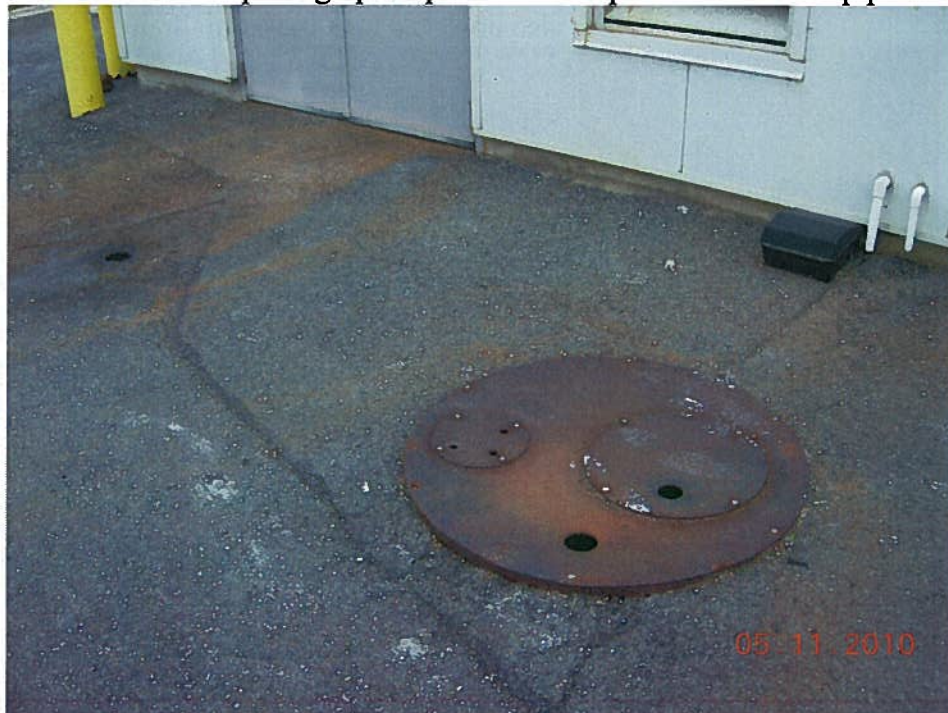
CWA 4: The manhole cover to the ash quench water pit located next to the unknown pipe.

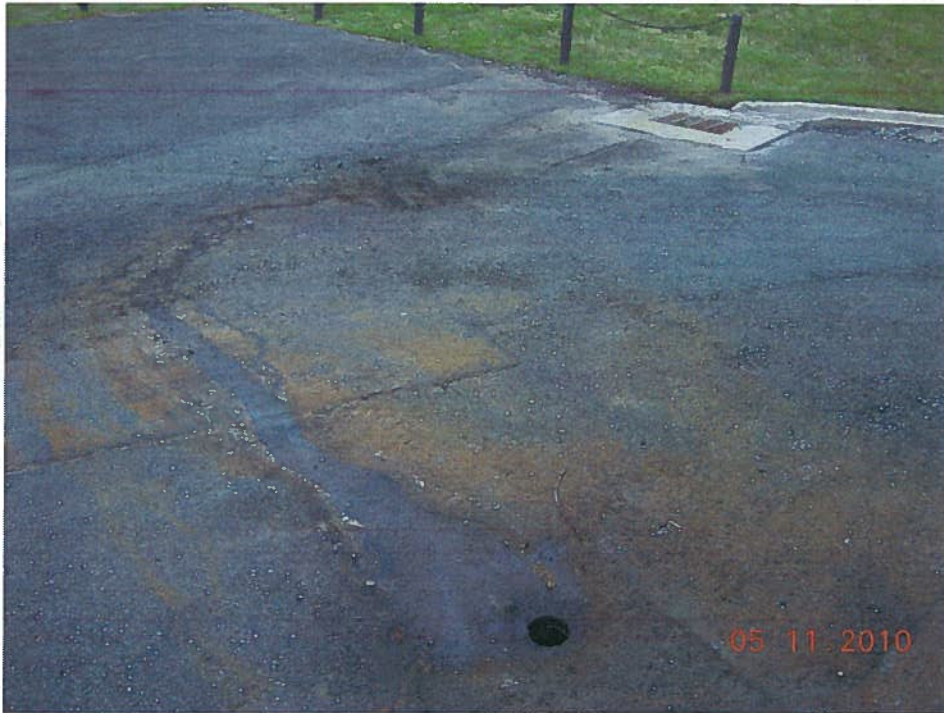
CWA 5: This photograph depicts another view of the discharge route of the unknown pipe to the storm drain.

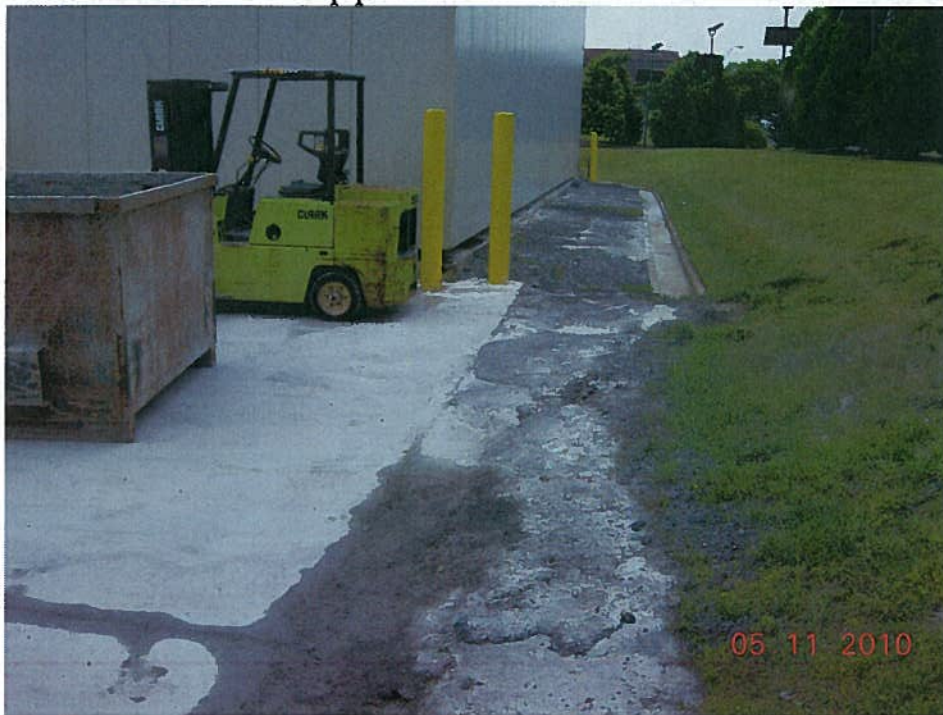
CWA 6: This photograph depicts white incinerator ash spilled on to ground outside of the Incineration Plant.

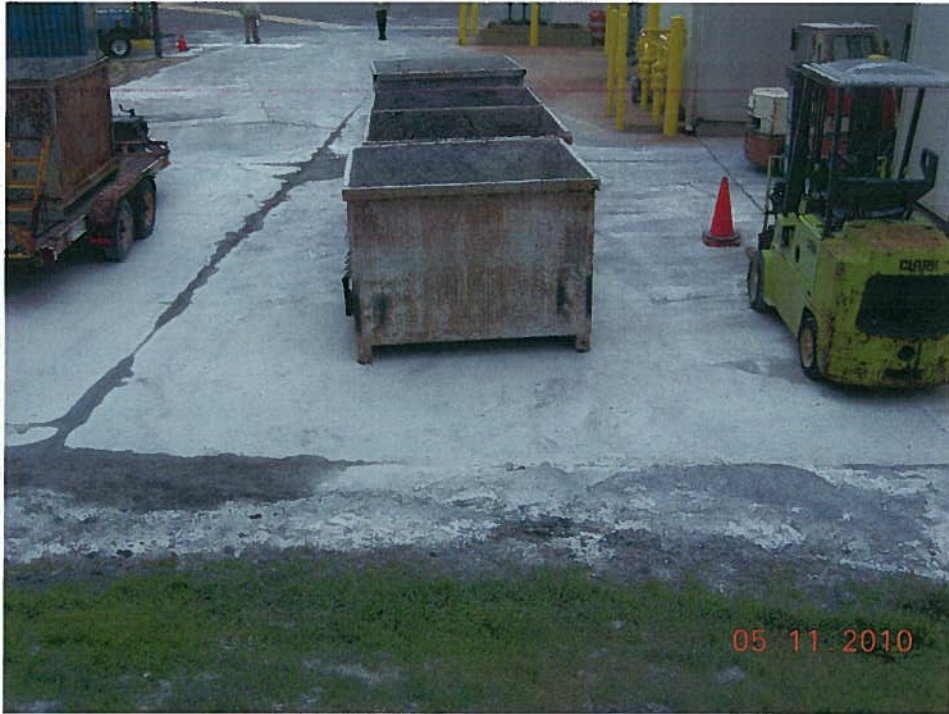
CWA 7: This photograph depicts ash bins with no covers.

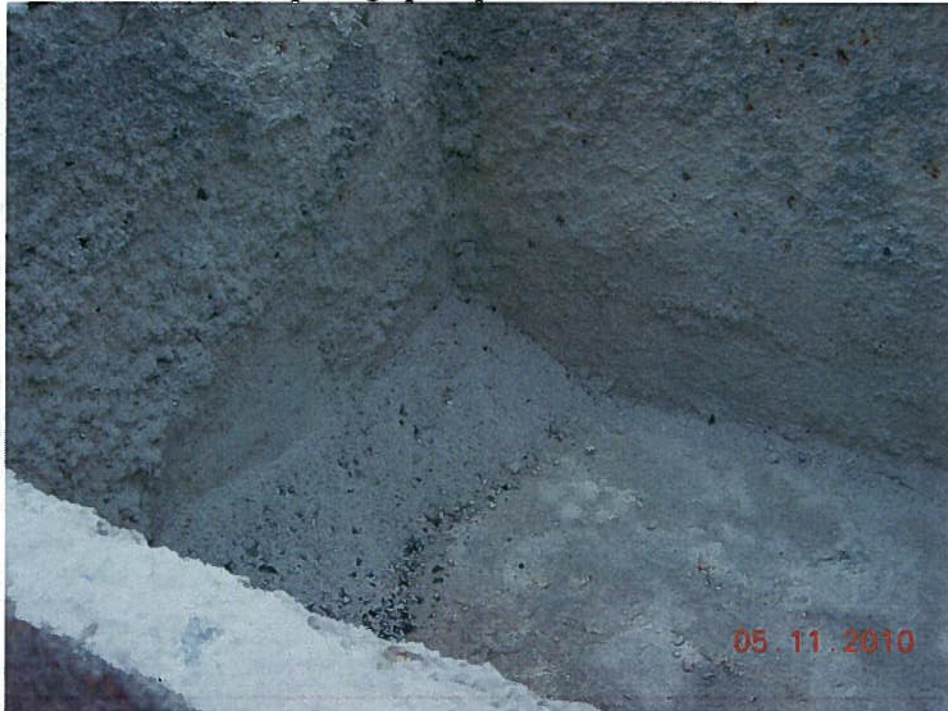
CWA 8: This photograph depicts the inside of one of the ash bins.

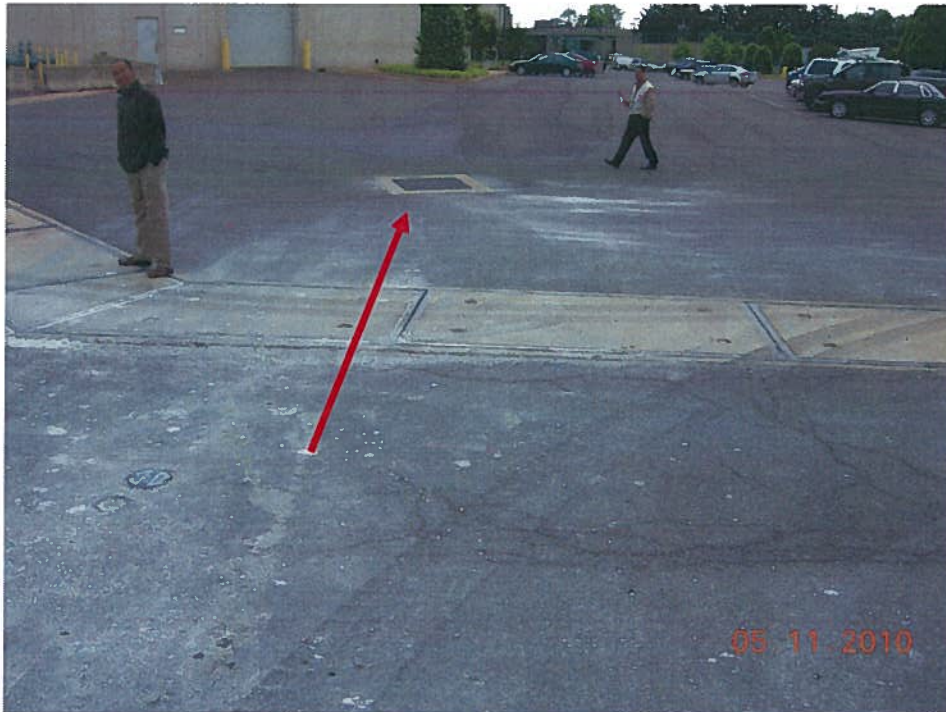
CWA 9: This photograph depicts white incinerator ash near a storm drain.

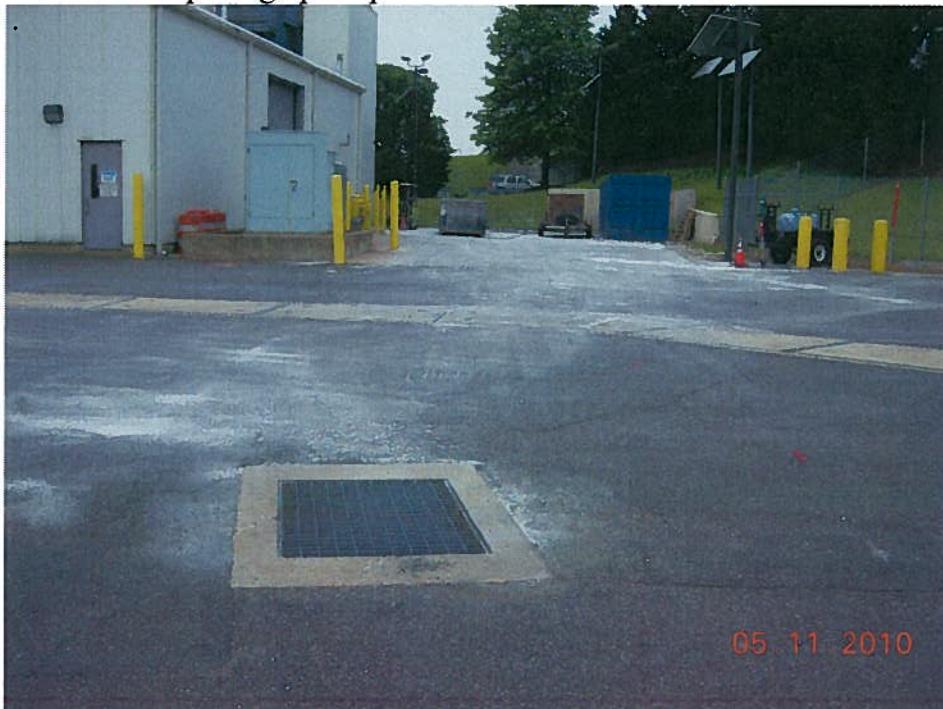
CWA 10: This photograph depicts an alternate view of the ash near the storm drain. The ash bin storage area is in the background.

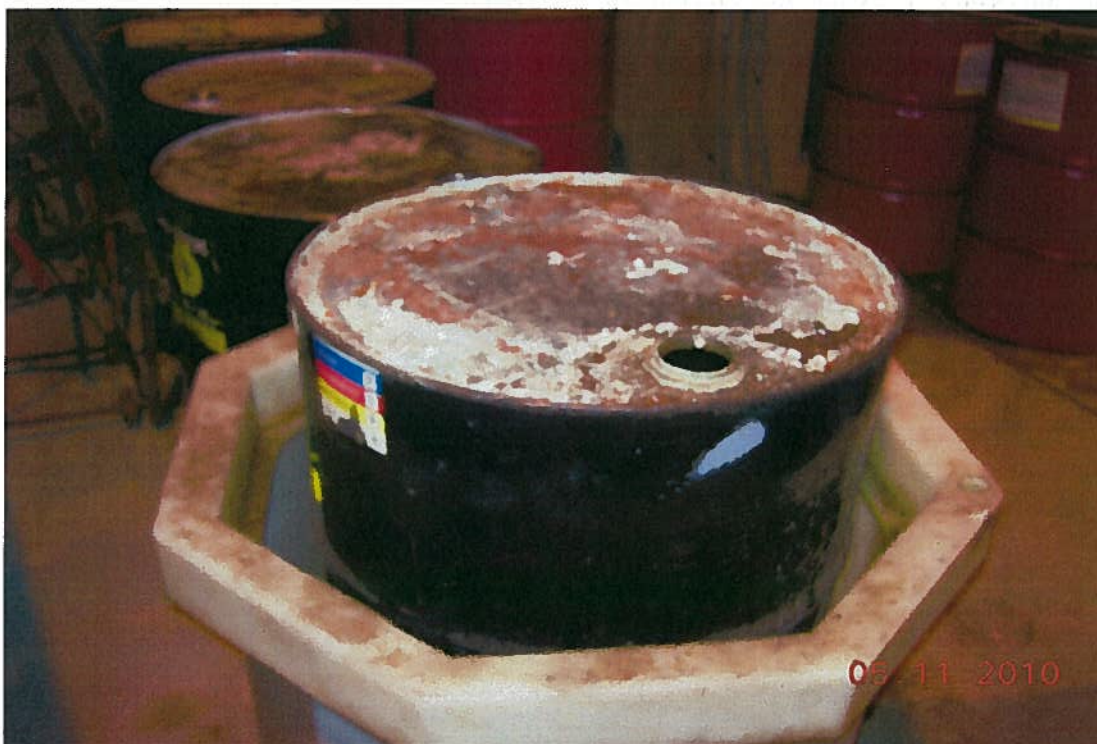
Photo No. SPCC 4 - Open black metal 55-gallon container at PHRP Basement HS Storage

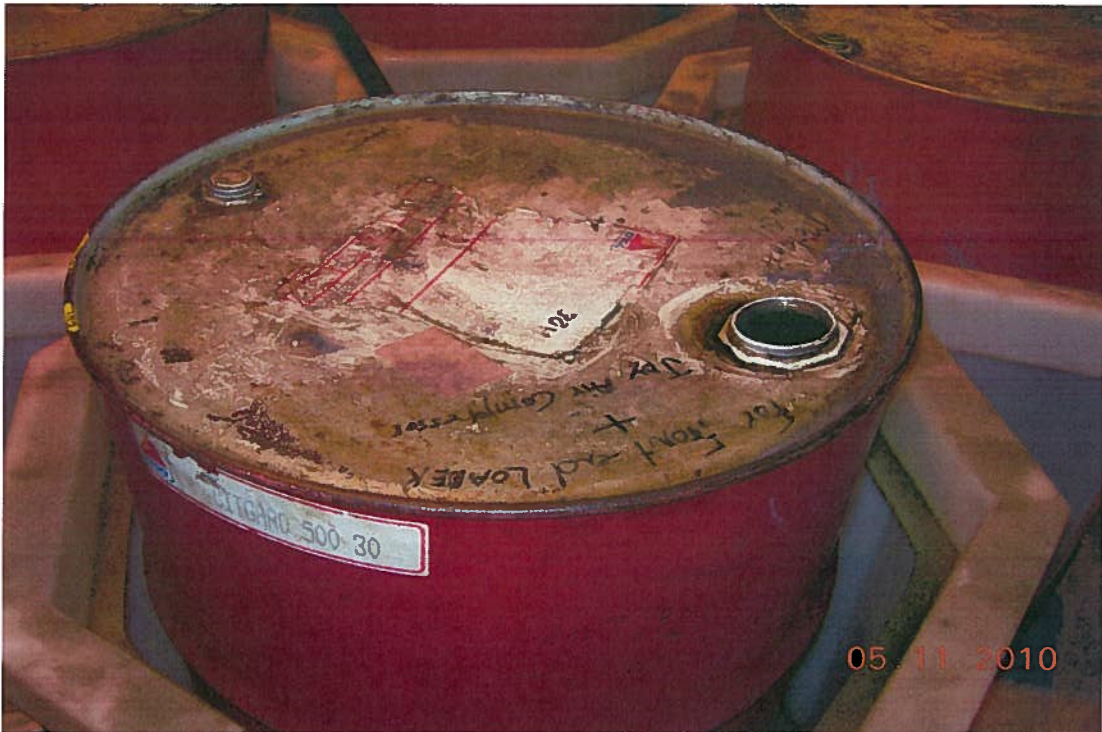
Photo No. SPCC 5 – Open red metal 55-gallon container at PHRP Basement HS Storage

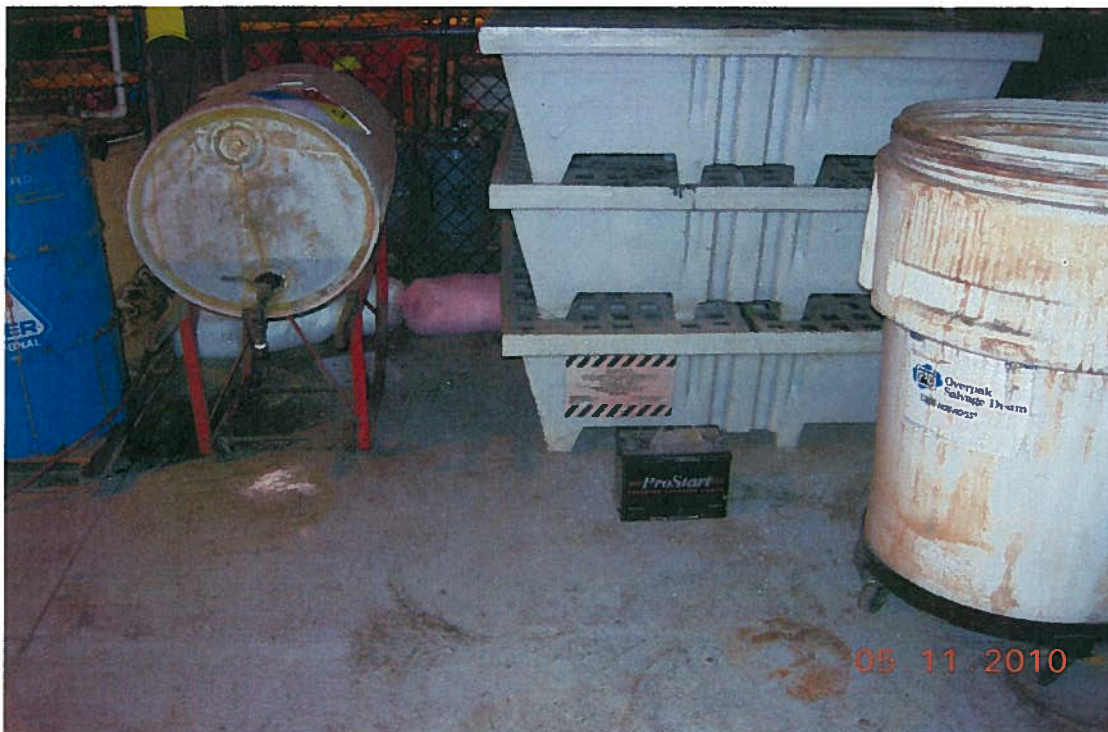
Photo No. SPCC 6 – Battery stored at the Open red metal 55-gallon container at PHRP Basement HS Storage
